# Restoration Masterplan Dunorlan Park, Royal Tunbridge Wells

April 2002

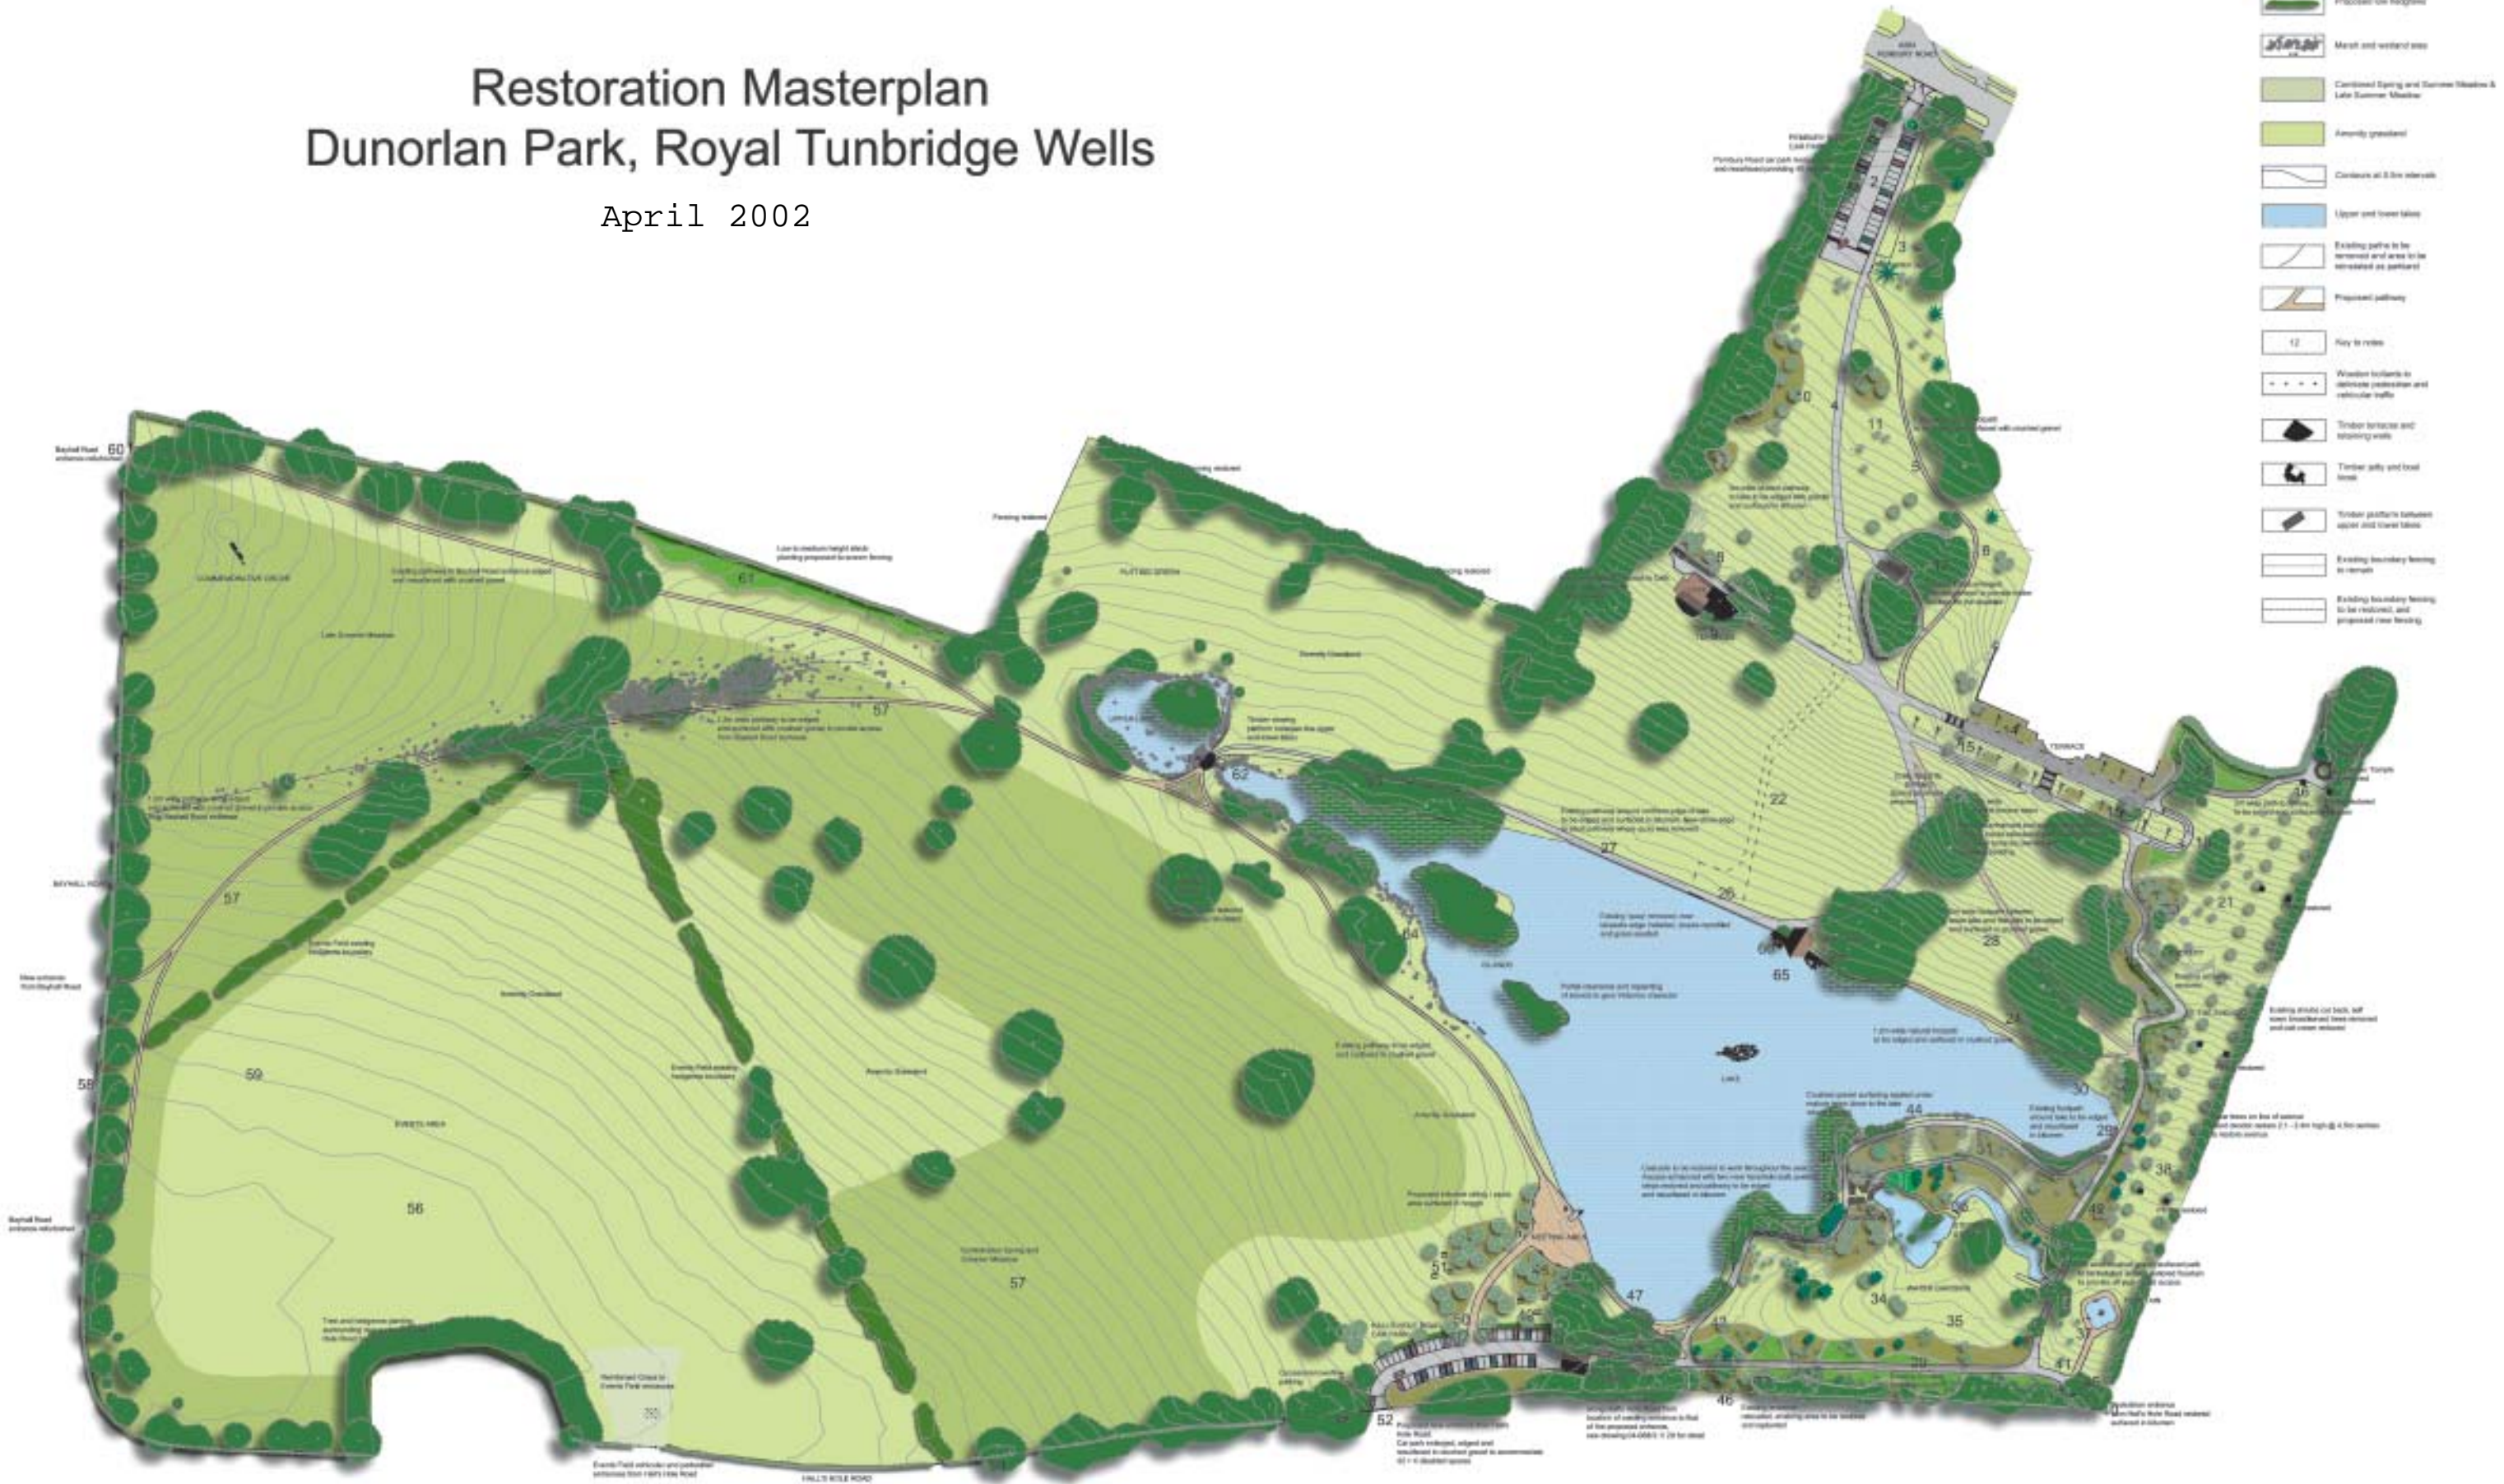
1. New vehicular entrance from Pembury Road.
2. Pembury Road car park reorganised and resurfaced in bitumen to accommodate 40 spaces.
3. Picnic area close to car park.

4. Comprehensive improvements to edgings and surfaces of all existing paths throughout the park.
5. Low to medium height shrubs planted adjacent to road frontage but not along the old chase to create intimate gardens.

6. Proposed crushed gravel surfaced pathway through pleasure gardens.
7. Proposed bitumen surfaced connection from terraces to toilet block.
8. Low to medium shrubs planted adjacent to cafe terraces.

9. New disabled accessible timber decked seating terraces associated with the cafe.
10. Original design reinstated with a mix of conifers and broadleaved trees.

11. Scattered specimen conifers.
12. Rhododendrons coppiced and interplanted with specimen trees and shrubs.
13. Tree and shrub planting reinstated along line of path and cafe.

14. Terrace banks to be reinstated with flowering shrubs.
15. Lower terrace to be planted with seasonal bedding.
16. Proposed new bitumen path connection to Grecian Temple.

17. Upper terraces to be resurfaced in stone paving. Lower in bitumen, with existing ramp removed and new stepped access incorporated.
18. New ramp provided to link upper and lower terraces enabling disabled access.

19. Existing bitumen path resurfaced and edged.
20. Rhododendrons and laurels cut back on either side of the path, enabling new shrubs to be planted. Rockery cleared and restored. Area above the rockery replanted with ornamental conifers.

21. Existing conifers retained and new conifers added.
22. Bitumen surfaced pedestrian and vehicular access to quay removed and reinstated as parkland.
23. Area replanted with ornamental trees.

24. Proposed crushed gravel surfaced path aligned with northern edge of lake to improve access around the lake edge.
25. Proposed new boating kiosk and jetties.

26. Existing vehicular access to lake removed and area restored to parkland.
27. Existing quay and terraces removed.
28. New bitumen surfaced path linking cafe with northern edge of lake, rationalising path structure.

29. Marginal and aquatic planting to soften lake edges and encourage wildlife.

30. Shrubs and trees planted close to lake edge to discourage pedestrian access close to lake.
31. Rhododendrons cut back and interplanted with shrubs allowing views between the paths. Area north of section path thinned to form gardenesque appearance.

32. Lake edges to be stabilised and crushed gravel surfaced jetties to be incorporated under existing broadleaved trees, to discourage erosion.
33. Pedestrian path to be enhanced and resurfaced in crushed gravel close to cascade.

34. Northern and eastern areas of the gardens thinned and cleared to shift axis, westwards reinstating original plan, encouraging long views down valley.

35. Picnic areas close to car park.
36. Timber retained crushed gravel path and steps restored linking the cascade with the water gardens.
37. Crushed gravel path around fountain. 38. Avenue replanted.

39. Shrubbery formed on northern side of the long path reinstating gardens to original design.
40. Pedestrian entrance into park from Halls Hole Road. 41. Specimen trees planted around fountain.

42. Existing bitumen path resurfaced and edged.
43. Comprehensive improvements to footpaths and edgings leading from car park to lake edge.
44. Additional marginal planting for more colour and seasonal interest.

45. Pedestrian entrance restored.
46. Existing Hall's Hole Road entrance closed and relocated to the west.
47. Crushed gravel edged path around south western side of lake to provide all year round access to lake.

48. Picnic area proposed adjacent to meeting area and Hall's Hole Road car park. 49. Hall's Hole Road car park reorganised to accommodate 46 spaces, shielded from the lake by low hedges and trees.

50. Proposed pedestrian/vehicular crushed gravel access pathway to slipway.
51. Oak and beech planted near to picnic area in groups of 3.
52. New entrance gates to create two way access into Hall's Hole Road car park.

53. Boat Storage Building.
54. Existing hedge and metal fencing to remain as perimeter enclosure to western side of park.
55. Reinforcement of grass at Events Field entrance.

56. Tree and shrub planting surrounding houses on Hall's Hole Road.
57. Crushed gravel link path providing all year round access from Bayhall Road into the park, maintaining access even when there are events.

58. New entrance gates to pedestrian access from Bayhall Road.
59. Crushed gravel path adjacent to Events Field, providing access across park. 60. Crushed gravel pedestrian path from northern end of Bayhall Road to upper lake.

61. Shrubs planted along northern boundary to shield fence.

62. Timber platform over stream between upper and lower lakes.
63. Pedestrian path edged and resurfaced in Bitumen.
64. Lake edging to be reclaimed and reinstated with dry stone.
65. Timber jetties adjacent to Boat Kiosk to enable ease of access for boat hire.
66. Timber safety fencing along path edge to prevent accidents for young children.
